# Broken engine's crankshaft misalignment inspection by using reverse engineering technique

W. Khuanlieng, S. Chuvaree, P. Janmanee \*

Department of Mechanical and Industrial Engineering, Faculty of Engineering, Rajamangala University of Technology Krungthep, Bangkok 10120, Thailand

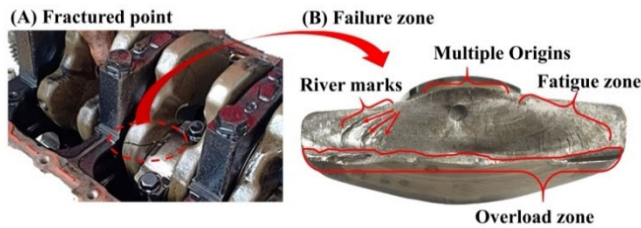
Fig. 2. Case study of the broken crankshaft; (A) the fractured point location; (B) cross section area of failure zone

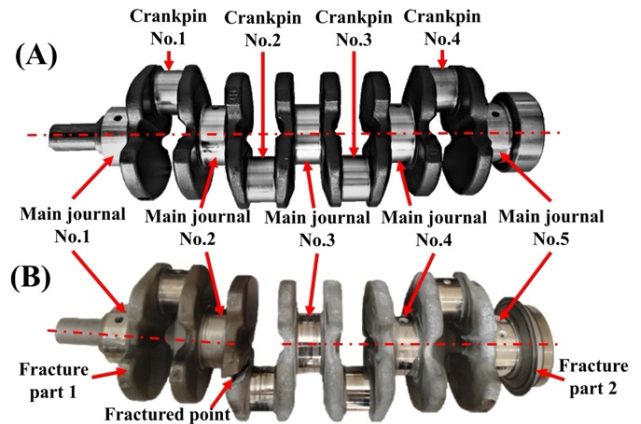
Authorized automotive manufacturers produced two interesting crankshafts. The broken crankshaft was removed from an engine after 470,000 km. In addition, the cracked

position was in Crankpin No. 2 after the disassembled process. The crankshaft was separated into two parts, and it was impossible to reconnect as the original one. Moreover, the crankshaft runout inspection cannot be measured by uncompleted parts. The technical nomenclature of the crankshaft and fractured position are shown in Figure 3.

Fig. 3. Crankshaft nomenclature; (A) the new crankshaft; (B) the broken crankshaft and fractured position

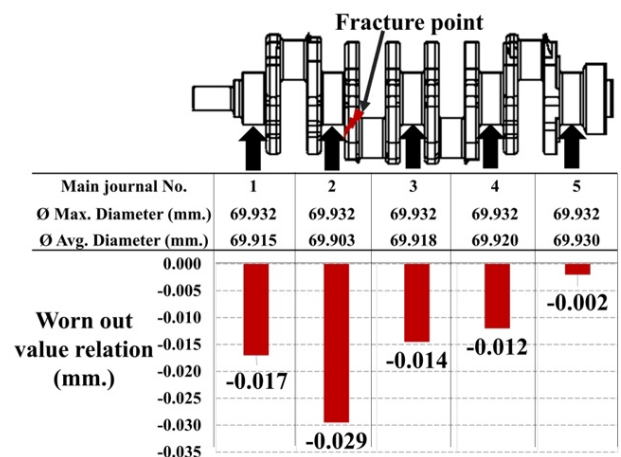
The measured value of the broken crankshaft is shown in Table 4. The worn-out value of each main crankshaft journal can be identified. Following the worn-out value of each main journal, the lowest measured value of the main journal diameter No. 2 was 69.890 mm. It was less than the limited value of 69.910 mm. Therefore, a new crankshaft was required to be replaced after inspection.

Fig. 9. Main journal diameter worn-out inspection of the broken crankshaft

Figure 9 presented the main journal diameter of the broken crankshaft. The measured value was compared with a maximum value when it was a new one. The actual worn-out value of average main journal diameter No. 5 was - 0.002 mm, which is the lowest worn-out rate. However, the actual worn-out value of average main journal diameter No. 2 was -0.029 mm, which is the highest worn-out rate. Considering the wear process, the material loss occurred due to the worn-out value relation of each main journal. The cross section area was changed by contact stress distribution while the crankshaft rotated. If the stress concentrations interfere with local concentrations of contact stresses, the surface coating may be damaged, and the wear resistance may deteriorate. Another parameter was the lubricating properties of the engine oil. If the viscosity accumulates impurities, they can act as an abrasive.[25] Generally, for the crankshaft in similar situations, all main journal diameters should be worn# closely to each other. In the case of the main journal, diameter No. 2 was immensely#worn out more than others. It was concerned with quality control on surface hardening in the heat treatment process. In addition, the worn-out value will be increased, and the clearance gap of the main journal-bearing shell will be expanded, which can lead to a misalignment of the crankshaft [26].

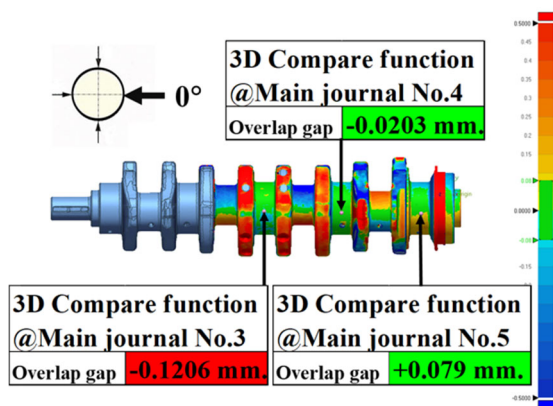
Fig. 14. The overlapping value measurement of the main journal at 0°

The 3D compare function shows the overlapping value of each main journal at 0° (Fig. 14). The overlapping value between two crankshafts is presented by observing visible colour with gap values. The range of green shade colour presented the overlap within an acceptable tolerance of

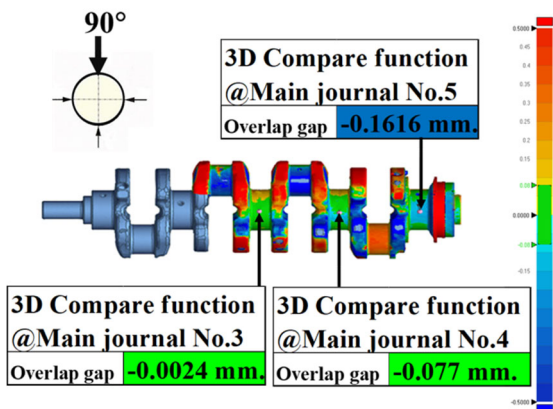
Fig. 15. The overlapping value measurement of the main journal at 90°

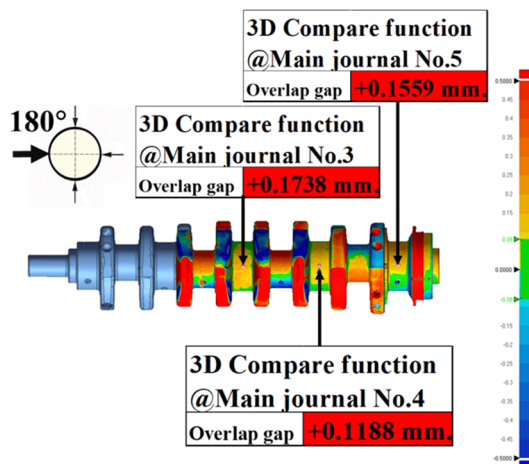
Fig. 16. The overlapping value measurement of the main journal at 180°

The measured value of the overlap seemed to be complicated in all 3D combined crankshafts. As a result, the overlapping value of main journal No. 3 at 180° was 0.1738 mm. which was the highest value in positive value. In addition, the main journals No. 4 and No. 5 at 180° also

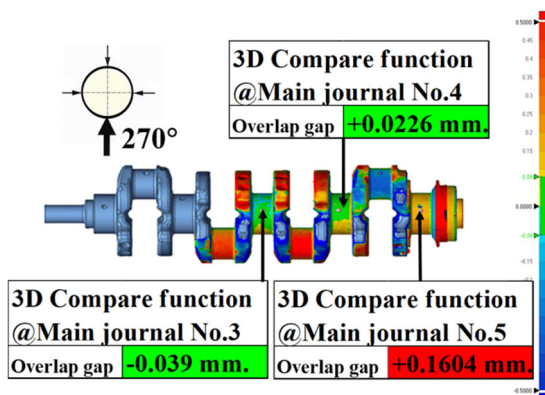
Fig. 17 The overlapping value measurement of the main journal at 270°

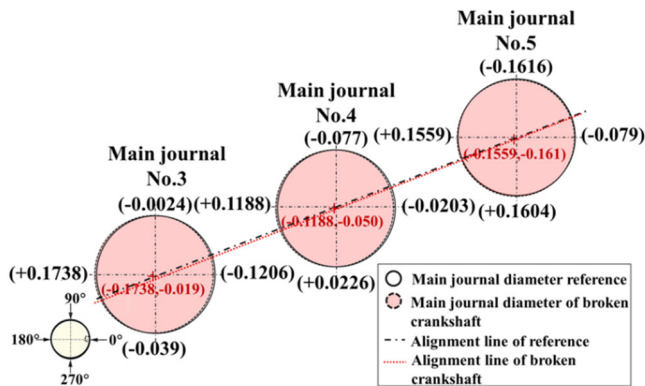
presented the overlapping value on the positive value with significance. On the other hand, all overlapping values at 0° and 90° are almost negative values. The overlapping values are plotted using a Cartesian coordinate plane on the main journal diameter reference, as shown in Figure 18.

Fig. 18 The overlapping values of the 3D combined crankshafts

Most crankshaft failures were usually related to misalignment issues. Meanwhile, they were under high bending or torsion moment [28]. Forecasting during engine operation, the unexpected bending stress will be affected in the critical zone of the crankshaft, where the crack can easily initiate [29,30]. The initial crack gradually increased depending on engine load operation. It was obvious in the highest overlapping value, which was consistent with the fractured position of the crankshaft.
