# Broken engine's crankshaft misalignment inspection by using reverse engineering technique

W. Khuanlieng, S. Chuvaree, P. Janmanee \*

Department of Mechanical and Industrial Engineering, Faculty of Engineering, Rajamangala University of Technology Krungthep, Bangkok 10120, Thailand

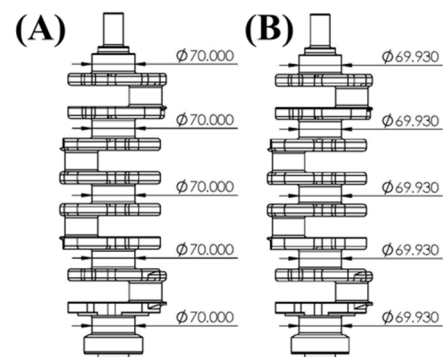
Fig. 11. (A) Main journal diameters were measured by a 3D laser scanner, and (B) main journal diameters were measured by a micrometre

The VXElements software has the capacity to produce 3D data in standard formats for any CAD platform. Both main journal diameter dimensions were measured by CAD software and a micrometre, as shown in Figure 11. The accuracy of scan data must be compared with the actual

measuring tool. The average main journal diameter of an artefact 3D model,  $d_{scan}$  was 70.000 mm. by a 3D laser scanner. Meanwhile, the average main journal diameter of an actual part,  $d_{ref}$  was 69.930 mm by a micrometer. Therefore, the measuring error,  $C_s$ , was calculated from  $70.000 - 69.930$  to be 0.070 mm. The results showed a measuring error over the accuracy limit of 0.030 mm. (Refer to data in Table 2). The technical specifications from HandySCAN700 are required for user-performed calibration procedures [27].

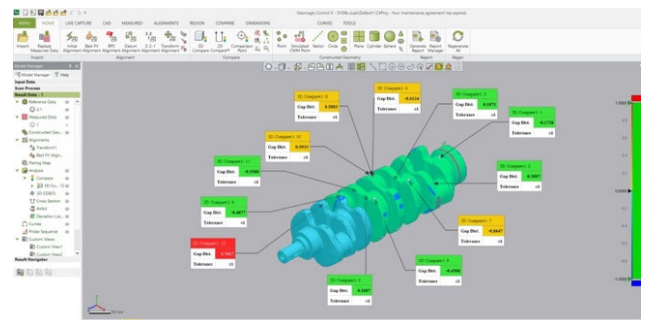
Fig. 12. The overlapping value was measured by Geomagic Control X software

Even in unexpected locations, wear and deformation have constantly been visible. The automated alignment and deviation features analysis can locate and measure specific points, as shown in Figure 12. The artefact 3D model of a new crankshaft was set as the reference. Consequently, the 3D new crankshaft and the 3D broken crankshaft are combined in concentric mate function to measure the overlapping value. It is illustrated in Figure 13.
